Flood Control Project Maintenance
2018 Structure Summary Report
Overall Unit and Item Ratings

Turlock Irrigation District Gomes Lake

Gomes Lake Pumping Plant

Flood Control Project Maintenance**Unit Cover Sheet****2018 Pumping Plant Inspection Results****Turlock Irrigation District Gomes Lake**

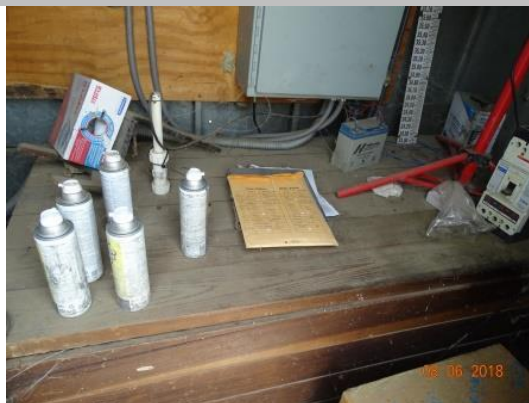
Photo 1 of 2 : ST_2018_NA0065_15_1_20180810_00018.jpg

LM Start	0.00	Rating **	A	Issue No.	1
LM End	0.00	Issue Type +	Ma	Location *	
Category	Pump Stations			GPS Latitude/Longitude	
				Start	End
Item	Operating Log			37.481567°	37.481567°
				-121.046617°	-121.046617°
DWR ID	DWR_NA0065_15_t_2012_1				
Action/Comments					
Inspector Comments: An operation log was present at the plant and the log was up to date.

View of the operating log. (2018)

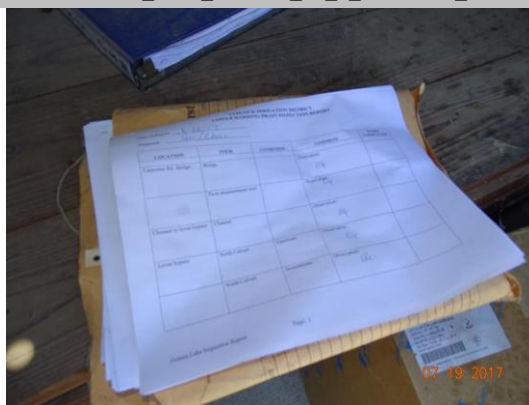
Photo 2 of 2 : ST_2018_NA0065_15_1_20180803_00001.jpg

View of the operating log. (2017)

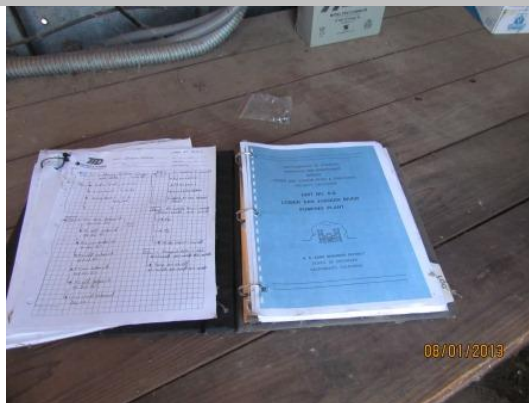
Photo 1 of 1 : ST_2018_NA0065_15_2_20180803_00002.jpg

LM Start	0.00	Rating **	A	Issue No.	2
LM End	0.00	Issue Type +	Ma	Location *	
Category	Pump Stations			GPS Latitude/Longitude	
				Start	End
Item	Operation & Maintenance Manual			37.481567 °	37.481567 °
				-121.046617 °	-121.046617 °
DWR ID	DWR_NA0065_15_t_2012_2				
Action/Comments					
Inspector Comments: The O&M manual kept at the office.

View of the O&M manual inside the plant.

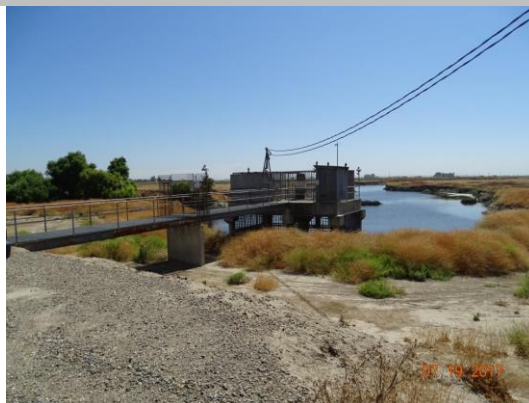
Photo 1 of 1 : ST_2018_NA0065_15_3_20180803_00003.jpg

LM Start	0.00	Rating **	A	Issue No.	3
LM End	0.00	Issue Type +	Ma	Location *	
Category	Pump Stations			GPS Latitude/Longitude	
				Start	End
Item	Plant Building			37.481567 °	37.481567 °
				-121.046617 °	-121.046617 °
DWR ID	DWR_NA0065_15_t_2012_3				
Action/Comments					
Inspector Comments: The plant building appeared to be in good structural condition with no major visible concrete damage.

View of the pumping plant. (2017)

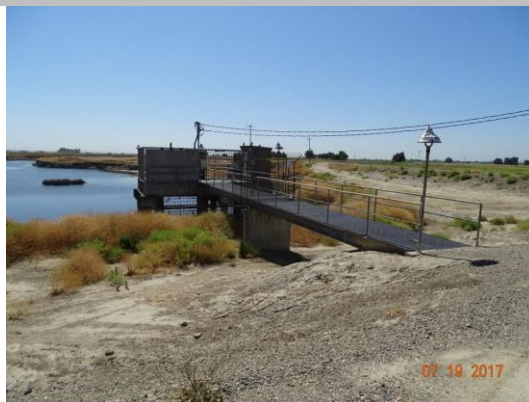
Photo 1 of 1 : ST_2018_NA0065_15_5_20180803_00004.jpg

LM Start	0.00	Rating **	A	Issue No.	5
LM End	0.00	Issue Type +	Ma	Location *	
Category	Pump Stations			GPS Latitude/Longitude	
				Start	End
Item	Safety			37.481567 °	37.481567 °
				-121.046617 °	-121.046617 °
DWR ID	DWR_NA0065_15_t_2012_5				
Action/Comments					
Inspector Comments: No safety hazards observed during the inspection.

View of the guard rails around the pumping plant.

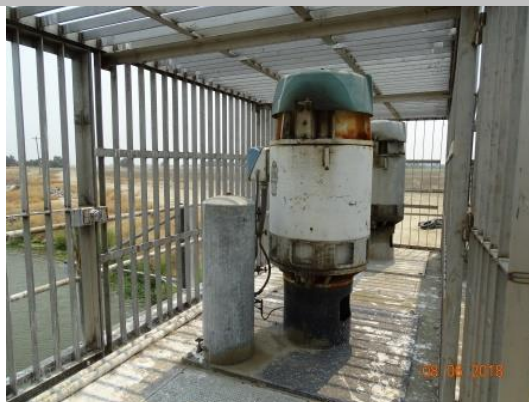
Photo 1 of 2 : ST_2018_NA0065_15_7_20180810_00019.jpg

LM Start	0.00	Rating **	A	Issue No.	7
LM End	0.00	Issue Type +	Ma	Location *	
Category	Pump Stations			GPS Latitude/Longitude	
				Start	End
Item	Pumps			37.481567 °	37.481567 °
				-121.046617 °	-121.046617 °
DWR ID	DWR_NA0065_15_t_2012_7				
Action/Comments					
Inspector Comments: All pumps appear maintained and lubricated. They are periodically tested.

Typical view of the pumps at the structure. (2018)

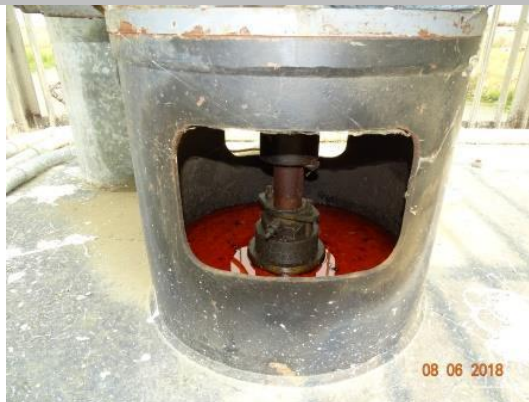
Photo 2 of 2 : ST_2018_NA0065_15_7_20180810_00020.jpg

View of bottom of the pump shaft. (2018)

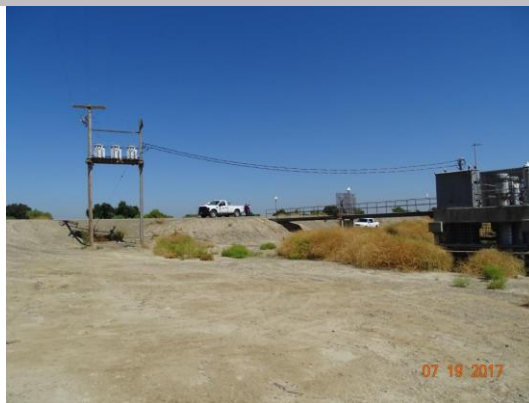
Photo 1 of 1 : ST_2018_NA0065_15_8_20180803_00008.jpg

LM Start	0.00	Rating **	A	Issue No.	8
LM End	0.00	Issue Type +	Ma	Location *	
Category	Pump Stations			GPS Latitude/Longitude	
				Start	End
Item	Power			37.481567 °	37.481567 °
				-121.046617 °	-121.046617 °
DWR ID	DWR_NA0065_15_t_2012_8				
Action/Comments					
Inspector Comments: Power delivered via the power grid. Appears adequate and reliable.

View of the power source at the plant. (2017)

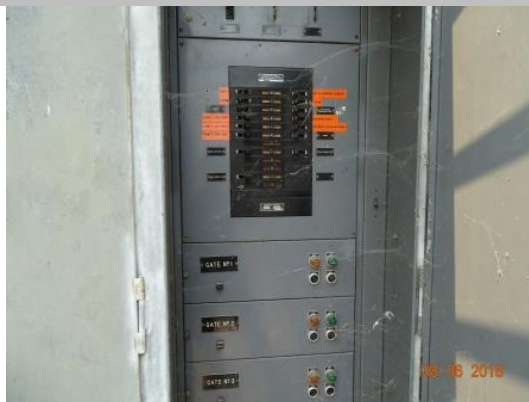
Photo 1 of 2 : ST_2018_NA0065_15_11_20180810_00021.jpg

LM Start	0.00	Rating **	A	Issue No.	11
LM End	0.00	Issue Type +	Ma	Location *	
Category	Pump Stations			GPS Latitude/Longitude	
				Start	End
Item	Pump Control Systems			37.481567 °	37.481567 °
				-121.046617 °	-121.046617 °
DWR ID	DWR_NA0065_15_t_2012_11				
Action/Comments					
Inspector Comments: The pump control system was operational and appeared to be free of any damage or corrosion.

View of control panel. (2018)

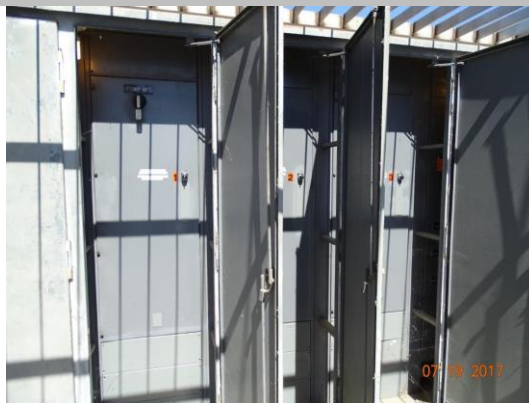
Photo 2 of 2 : ST_2018_NA0065_15_11_20180803_00009.jpg

View of the pump control boxes. (2017)

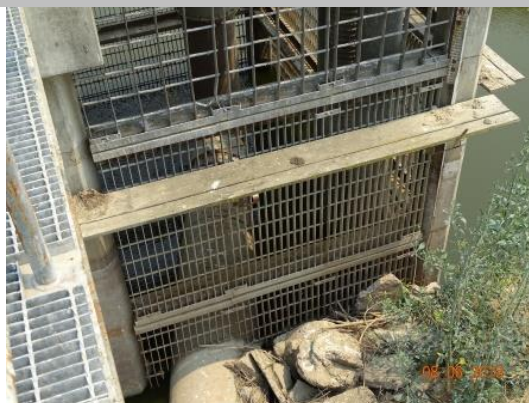
Photo 1 of 1 : ST_2018_NA0065_15_12_20180810_00022.jpg

LM Start	0.00	Rating **	A	Issue No.	12
LM End	0.00	Issue Type +	Ma	Location *	
Category	Pump Stations			GPS Latitude/Longitude	
				Start	End
Item	Sumps/Wet Well			37.481567 °	37.481567 °
				-121.046617 °	-121.046617 °
DWR ID	DWR_NA0065_15_t_2012_12				
Action/Comments					
Inspector Comments: The sump well was clear of excessive debris and other obstructions.

View of wet well. (2018)

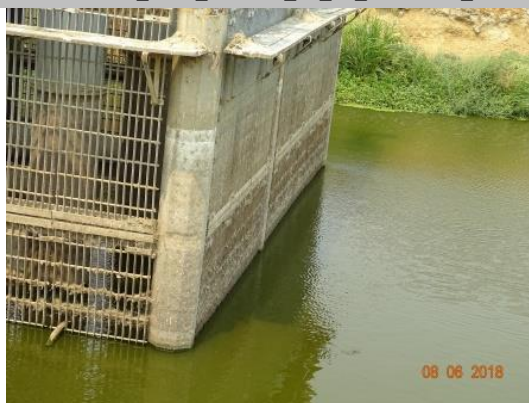
Photo 1 of 1 : ST_2018_NA0065_15_13_20180810_00023.jpg

LM Start	0.00	Rating **	A	Issue No.	13
LM End	0.00	Issue Type +	Ma	Location *	
Category	Pump Stations			GPS Latitude/Longitude	
				Start	End
Item	Trash Racks			37.481567 °	37.481567 °
				-121.046617 °	-121.046617 °
DWR ID	DWR_NA0065_15_t_2012_13				
Action/Comments					
Inspector Comments: The trash racks were free of debris and appeared to be maintained properly.

View of trash racks. (2018)

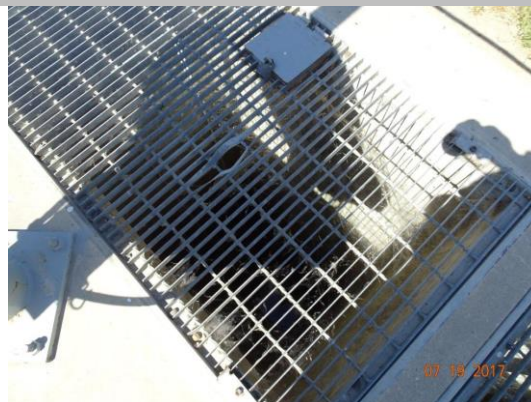
Photo 1 of 1 : ST_2018_NA0065_15_15_20180803_00012.jpg

LM Start	0.00	Rating **	A	Issue No.	15
LM End	0.00	Issue Type +	Ma	Location *	
Category	Pump Stations			GPS Latitude/Longitude	
				Start	End
Item	Sluice / Slide Gates			37.481567 °	37.481567 °
				-121.046617 °	-121.046617 °
DWR ID	DWR_NA0065_15_t_2012_15				
Action/Comments					
Inspector Comments: The slide gates were free of any debris and appeared to be in good working condition.

View of the slide gate on the outlet structure. (2017)

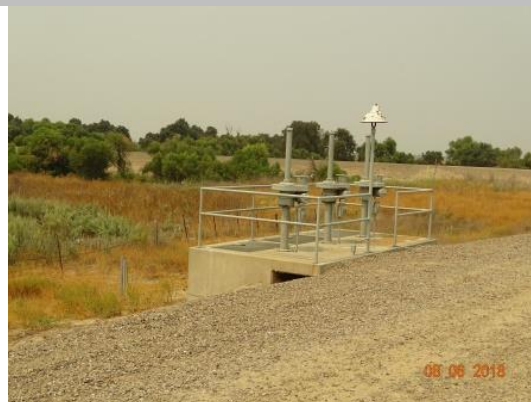
Photo 1 of 1 : ST_2018_NA0065_15_16_20180810_00024.jpg

LM Start	0.00	Rating **	A	Issue No.	16
LM End	0.00	Issue Type +	Ma	Location *	
Category	Pump Stations			GPS Latitude/Longitude	
				Start	End
Item	Electric Gate Operators			37.481567 °	37.481567 °
				-121.046617 °	-121.046617 °
DWR ID	DWR_NA0065_15_t_2013_16				
Action/Comments					
Inspector Comments: The electric gate operators were in good working condition.

View of electric gate operators. (2018)

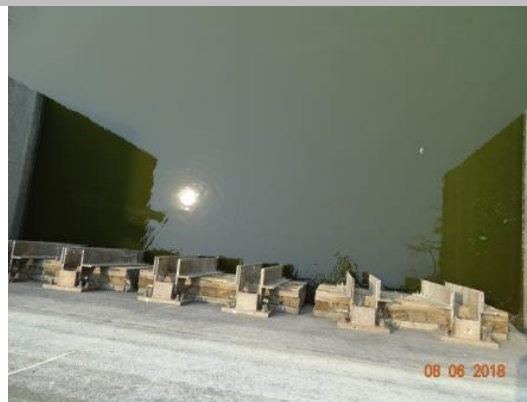
Photo 1 of 1 : ST_2018_NA0065_15_19_20180810_00025.jpg

LM Start	0.00	Rating **	A	Issue No.	19
LM End	0.00	Issue Type +	Ma	Location *	
Category	Pump Stations			GPS Latitude/Longitude	
				Start	End
Item	Flap Gates			37.481567 °	37.481567 °
				-121.046617 °	-121.046617 °
DWR ID	DWR_NA0065_15_t_2012_19				
Action/Comments					
Inspector Comments: The flap gates appeared to be in good working condition.

View of flap gates. (2018)

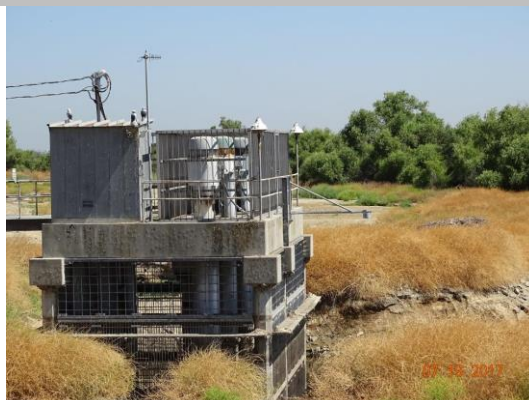
Photo 1 of 2 : ST_2018_NA0065_15_21_20180803_00015.jpg

LM Start	0.00	Rating **	A	Issue No.	21
LM End	0.00	Issue Type +	Ma	Location *	
Category	Pump Stations			GPS Latitude/Longitude	
				Start	End
Item	Security Fencing			37.481567 °	37.481567 °
				-121.046617 °	-121.046617 °
DWR ID	DWR_NA0065_15_t_2012_21				
Action/Comments					
Inspector Comments: The security fencing appeared to be in good condition and should provide protection against unauthorized access.

View of the steel cage around the pumps on the structure. (2017)

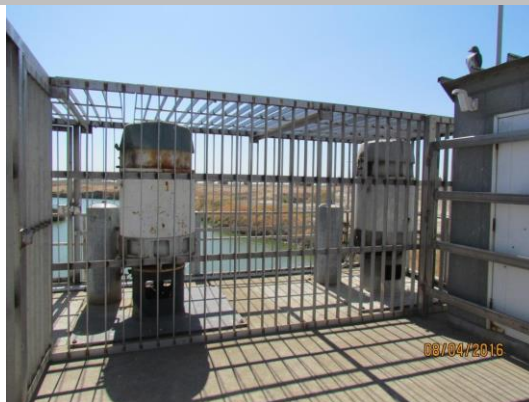
Photo 2 of 2 : ST_2018_NA0065_15_21_20180803_00016.jpg

View of the steel cage inside the plant. (2016)

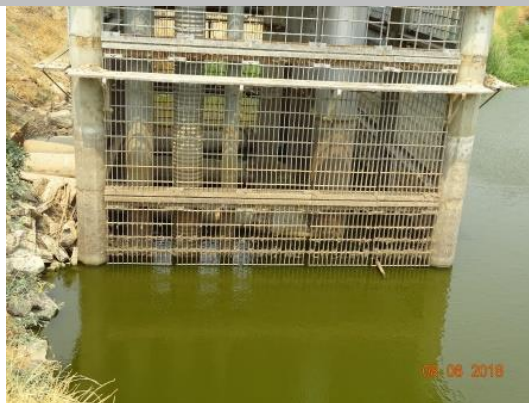
Photo 1 of 1 : ST_2018_NA0065_15_22_20180810_00026.jpg

LM Start	0.00	Rating **	A	Issue No.	22
LM End	0.00	Issue Type +	Ma	Location *	
Category	Pump Stations			GPS Latitude/Longitude	
				Start	End
Item	Intake and Discharge Pipes			37.481567 °	37.481567 °
				-121.046617 °	-121.046617 °
DWR ID	DWR_NA0065_15_t_2012_22				
Action/Comments					
Inspector Comments: The intake and discharge pipes appeared to be free of any breaks, holes or cracks.

View of intake pipes. (2018)

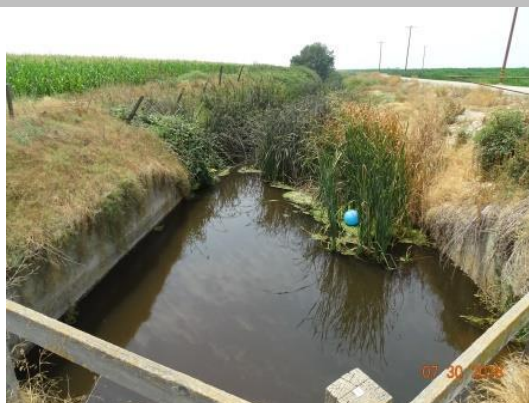
Photo 1 of 3 : ST_2018_NA0065_70_2_20180810_00022.jpg

LM Start	0.00	Rating **	A	Issue No.	2
LM End	0.00	Issue Type +	Ma	Location *	
Category	Structures & Concrete Lined Channels			GPS Latitude/Longitude	
				Start	End
Item	Vegetation & Obstructions			37.390522 °	37.390522 °
				-120.941096 °	-120.941096 °
DWR ID	DWR_NA0065_70_t_2017_2				
Action/Comments					
Inspector Comments: Moderate vegetation including cat tails was found in channel near all 3 components of this structure and should be managed to prevent degradation of channel capacity.

View of vegetation at the outlet of the siphon. (2018)

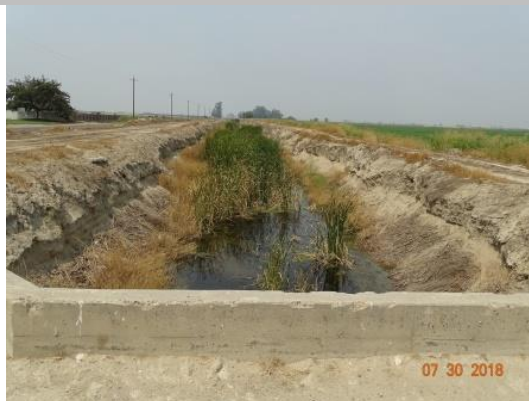
Photo 2 of 3 : ST_2018_NA0065_70_2_20180810_00023.jpg

View of vegetation upstream of lateral 7 gate. (37.394123, -120.940805)
(2018)

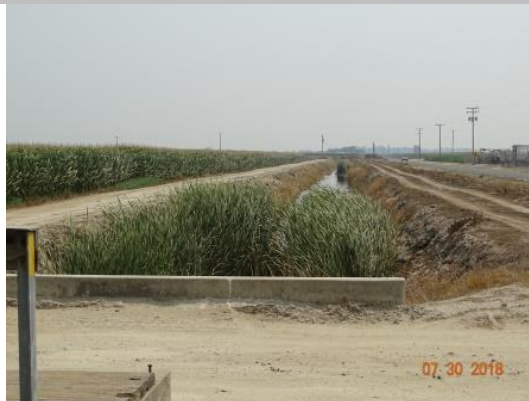
Photo 3 of 3 : ST_2018_NA0065_70_2_20180810_00024.jpg

View of vegetation downstream of lateral 7 gate. (37.394123, -120.940805) (2018)

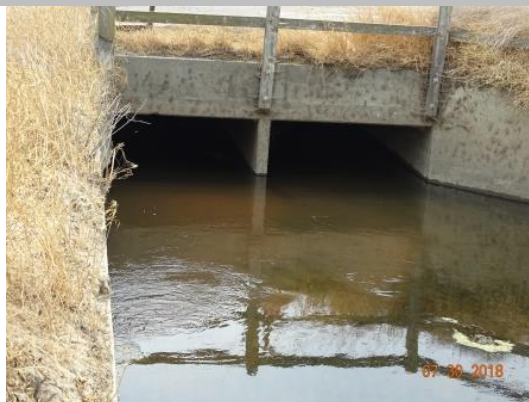
Photo 1 of 4 : ST_2018_NA0065_70_7_20180813_00025.jpg

LM Start	0.00	Rating **	A	Issue No.	7
LM End	0.00	Issue Type +	Ma	Location *	
Category	Structures & Concrete Lined Channels			GPS Latitude/Longitude	
				Start	End
Item	Culverts: Inlets / Outlets			37.390522 °	37.390522 °
				-120.941096 °	-120.941096 °
DWR ID	DWR_NA0065_70_t_2017_7				
Action/Comments					
Inspector Comments: Inlet and outlet culvert were working fine without significant blockage during the inspection.

View of the inlet culvert at the siphon structure. (2018)

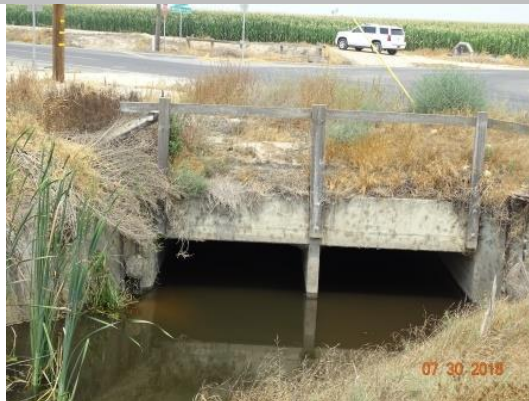
Photo 2 of 4 : ST_2018_NA0065_70_7_20180813_00026.jpg

View of the outlet culvert at the siphon structure. (2018)

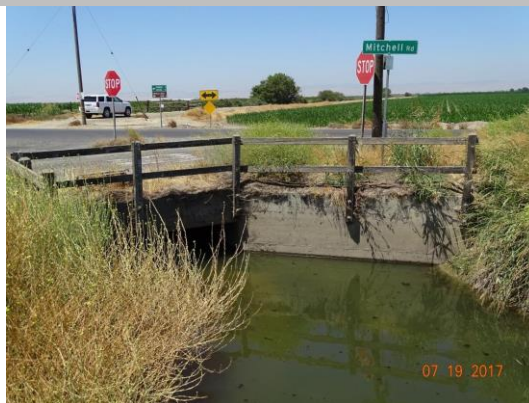
Photo 1 of 1 : ST_2018_NA0065_70_8_20180803_00013.jpg

LM Start	0.00	Rating **	A	Issue No.	8	
LM End	0.00	Issue Type +	Ma	Location *		
Category	Structures & Concrete Lined Channels			GPS Latitude/Longitude		
				Start		End
Item	Culverts: Breaks / Holes / Cracks			37.390522 °		37.390522 °
				-120.941096 °		-120.941096 °
DWR ID	DWR_NA0065_70_t_2017_8					
Action/Comments						
Inspector Comments: No significant damage was found at the culverts.

View of the inlet culvert at the siphon structure looking west.

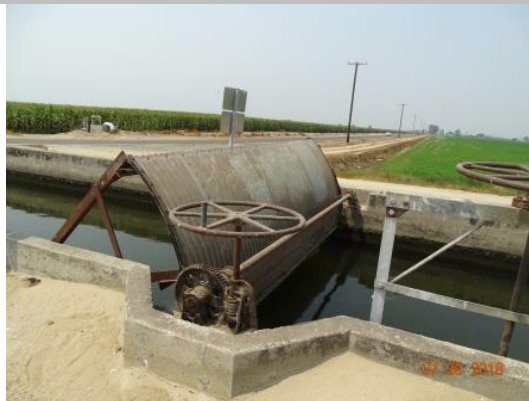
Photo 3 of 5 : ST_2018_NA0065_70_12_20180813_00029.jpg

View of the radial gate at lateral 6. (37.406061, -120.940602) (2018)

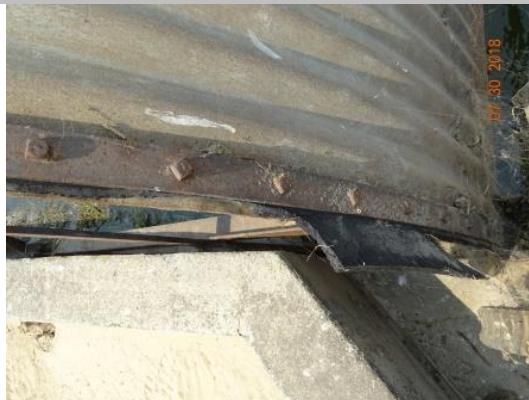
Photo 5 of 5 : ST_2018_NA0065_70_12_20180813_00030.jpg

LM Start	0.00	Rating **	A	Issue No.	12
LM End	0.00	Issue Type +	Ma	Location *	
Category	Structures & Concrete Lined Channels	GPS Latitude/Longitude			
		Start	End		
Item	Sluice/Slide Gates	37.390522 °		37.390522 °	
		-120.941096 °		-120.941096 °	
DWR ID	DWR_NA0065_70_t_2017_12				
Action/Comments					
Inspector Comments: Lateral 6 (37.406061,-120.940602) and lateral 7 (37.394123,-120.940805) control gates divert the water through the siphon structure during flood flow stage. The gasket on the radial gate at lateral 6 has deteriorated and should be replaced.

Deteriorated gasket on radial gate at lateral 6 should be replaced. (2018)

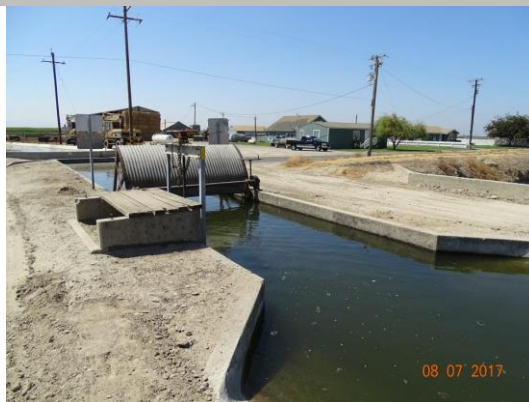
Photo 1 of 2 : ST_2018_NA0065_70_14_20180803_00016.jpg

LM Start	0.00	Rating **	A	Issue No.	14
LM End	0.00	Issue Type +	Ma	Location *	
Category	Structures & Concrete Lined Channels	GPS Latitude/Longitude			
		Start	End		
Item	Manual Gate Operators	37.390522 °		37.390522 °	
		-120.941096 °		-120.941096 °	
DWR ID	DWR_NA0065_70_t_2017_14				
Action/Comments					
Inspector Comments: Manual gates at lateral 6 (37.406061,-120.940602) and lateral 7 (37.394123,-120.940805) should be greased for maintenance, but appear to be in working condition.

View of the manual gate at lateral 7. (2017)

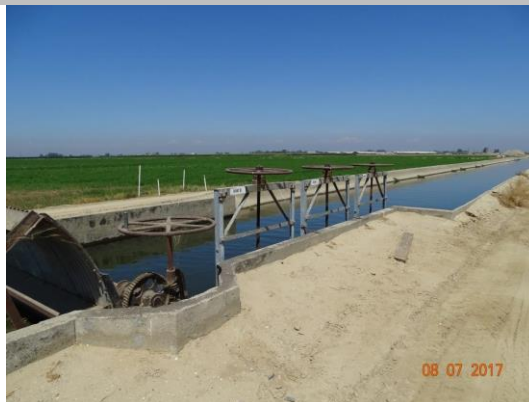
Photo 2 of 2 : ST_2018_NA0065_70_14_20180803_00017.jpg

View of the manual gates at lateral 6. (2017)

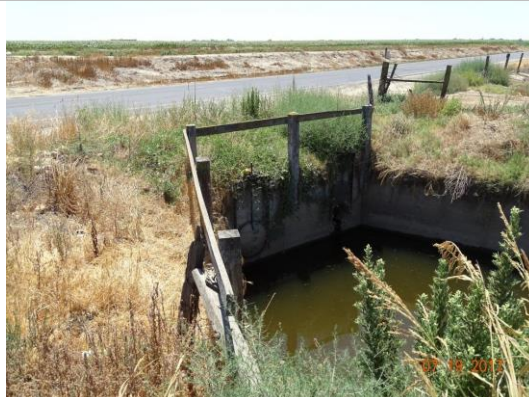
Photo 1 of 3 : ST_2018_NA0065_70_23_20180803_00018.jpg

LM Start	0.00	Rating **	A	Issue No.	23	
LM End	0.00	Issue Type +	Ma	Location *		
Category	Structures & Concrete Lined Channels			GPS Latitude/Longitude		
				Start		End
Item	Safety			37.390522 °		37.390522 °
				-120.941096 °		-120.941096 °
DWR ID	DWR_NA0065_70_t_2017_23					
Action/Comments						
Inspector Comments: Safety railings were in a good condition.

View of the wooden rails at the outlet of the structure. (2017)

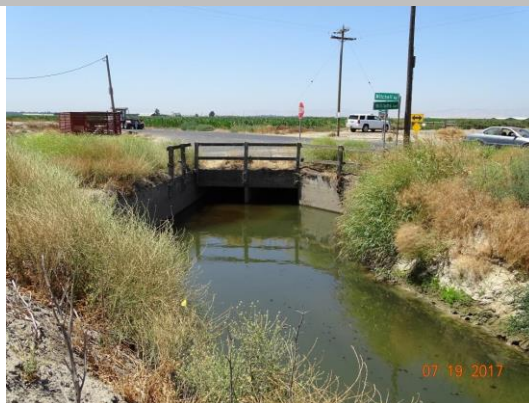
Photo 2 of 3 : ST_2018_NA0065_70_23_20180803_00019.jpg

View of the wooden rails at the inlet of the structure. (2017)

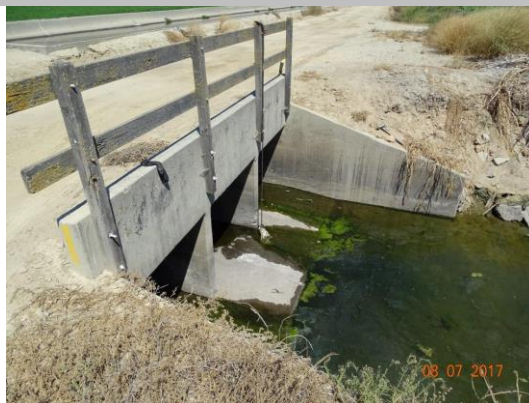
Photo 3 of 3 : ST_2018_NA0065_70_23_20180803_00020.jpg

View of the wooden rails at the lateral 6 outlet structure. (37.406061, -120.940602) (2017)
